# LaserJet / LJ2000 Troubleshooting Guide

**Volume 1**  
**April 1995**  
**Revision 13**

# The Classic LaserJet Troubleshooting Manual

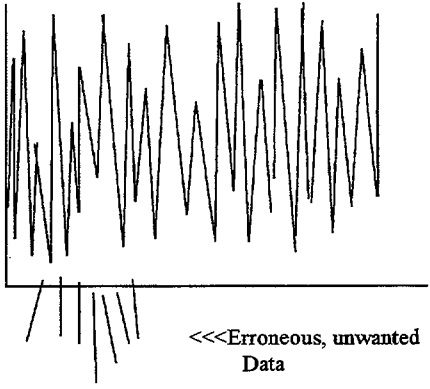
<p><b>Eroneous lines</b> appearing on XY Chart, printing in HPGL2, see example opposite. The problem appears the more complex the XY Chart plot is.</p> <p style="text-align: center;"><i>(LJIII)</i></p>	<ol style="list-style-type: none"> <li>1. Use latest revision of firmware (DC 19900430) on the Formatter PCA.</li> </ol>

<p style="text-align: right;">&lt;&lt;&lt;Erroneous, unwanted Data</p>
<p style="text-align: center;"><b>LJIII Intermittently drops OFF-LINE?</b></p> <p style="text-align: center;"><i>(G. Clark - Leeds - Jan 94)</i></p>	<p style="text-align: center;"><i>Replacing Formatter PCA seem to resolve this phm.</i></p>
<p><b>COMPLETELY DEAD?</b> No Display, <b>ERROR 12</b>, this fault could be <b>Intermittent</b>.</p> <p style="text-align: center;"><i>(Updated)</i></p>	<ol style="list-style-type: none"> <li>1. <i>Replace DC Controller PCA.</i></li> <li>2. <i>Replace Formatter PCA</i></li> <li>3. Remove any PCA installed in the Optional I/O (JetDirect XIO, i-Data, etc), is fault resolved? If not <i>replace this PCA.</i></li> <li>4. <i>Replace DC Power Supply.</i> If the DC Controller &amp; Formatter PCA are removed you can check DCPS by grounding pin 7, <i>Remote Enable line</i>, on the DC Power Supply, if the supply is OK the +/- 5v &amp; 24v should come up. If not replace DC Power Supply Module.</li> </ol> <p><i>See Flow Diagram towards beginning of this section</i></p>

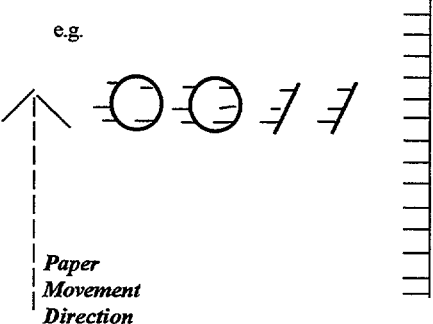
<p><b>HORIZONTAL Displacement LH PARTS OF ALL CHARACTERS (LANDSCAPE MODE).</b>  Chars are clearly formed (i.e. NOT fuzzy) but have distinctive LH tails (in this case a row at the top and bottom, and one in the middle). See Example opposite.</p>	<p><i>Faulty SCANNER MOTOR assembly.</i></p>

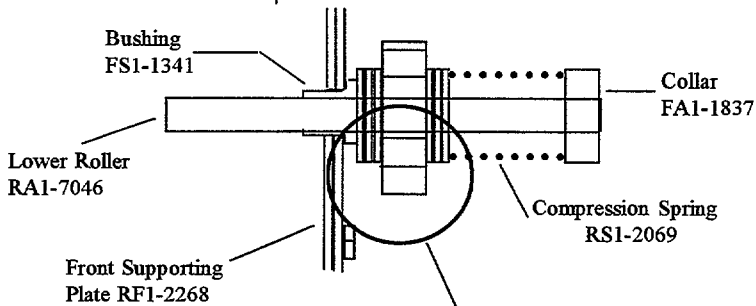
**13.2 PAPER JAMS in Switchback (Positive Drive).**  
 Seemingly insufficient friction as it passes through 3 driven Rollers.  
 (Tim Webster Cen-Lon)

The fix was due to a disintegrating washer, refer to page 8b-22 item 67 (Roller Shaft/Roller), it can be seen it consists of 2 rubber washers & 4 carbon keyed washers and 1 free running gear, a compression rollers spring & a retaining collar (This assy acts as a clutch). This disintegrating washer causes this clutch to slip, thus 13.2 paper jams. *Replace rubber washers, see below: NOTE the diagram below does not appear in Service Manual.*

- 1) Washer RA1-7044
- 2) Washer RA1-1575
- 3) Rubber Washer RS1-6021

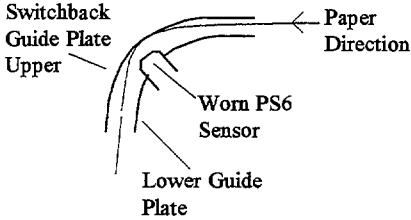
<p><b>ERROR 13.1</b>, paper intermittently will not enter switchback from Fuser. It is observed that when this condition exists, none of the rollers in the switchback move. <i>(Dave Malone - Manchester)</i></p>	<p>The 24v in FDS(stacker) was measured at 20v. <i>Replacing Stacker Power Supply fixed this problem.</i></p>
<p><b>13.2 then 13.1 Paper Jam</b> (double ping) in switchback. <i>(Lee Williams - Billerica)</i> <i>(New Info)</i></p> <p><i>Diagram opposite shows how the paper can bypass PS6 sensor when the sensor flag is worn. Stiffer paper can also contribute.</i></p>	<p>To troubleshoot disable Paper Jam on Stacker Control PCA, if jam does not occur then electrical/sensor problem. In this case no paper jams occurred when PJ occurred. It was found that PS6 sensor flag was worn. As paper moved downwards into the switchback intermittently the paper would miss PS6 sensor flag due to the combination of wear of the flag and the bend the paper is trying to negotiate. This LJ2000 had printed 4 million images. Check also that SL5 deflector gap is set to approx 2mm. <i>To resolve this problem PS6 sensor/flag was replaced.</i></p>
