# Ethernet and LocalTalk Products

Ethernet and LocalTalk Products

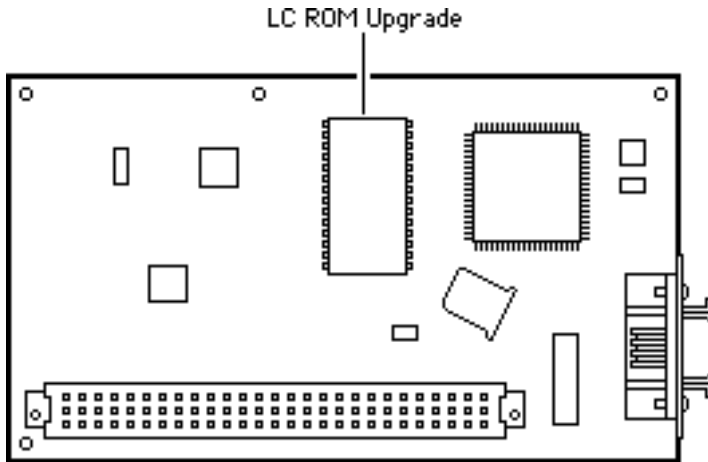
The Ethernet LC Upgrade allows the original Ethernet LC card to be used in the Macintosh LC II.

The upgrade is required on Ethernet LC cards (part number 661-0621) used in the Macintosh LC II.

- 1 Carefully remove the ROM from location U1.
- 2 Install the new ROM. Pin 1 should be in the upper-left corner.
